AAA Home Inspections

Property Inspection Report

1120 N. 3rd Street , San Jose, CA
Inspection prepared for: Richard Wells & Ann Wells
Real Estate Agent: George Sudol - Bay Realty Services

Date of Inspection: 1/31/2020 Time: 9:00
Age of Home: 81 Size: 1379 s.f.
Weather: Sunny

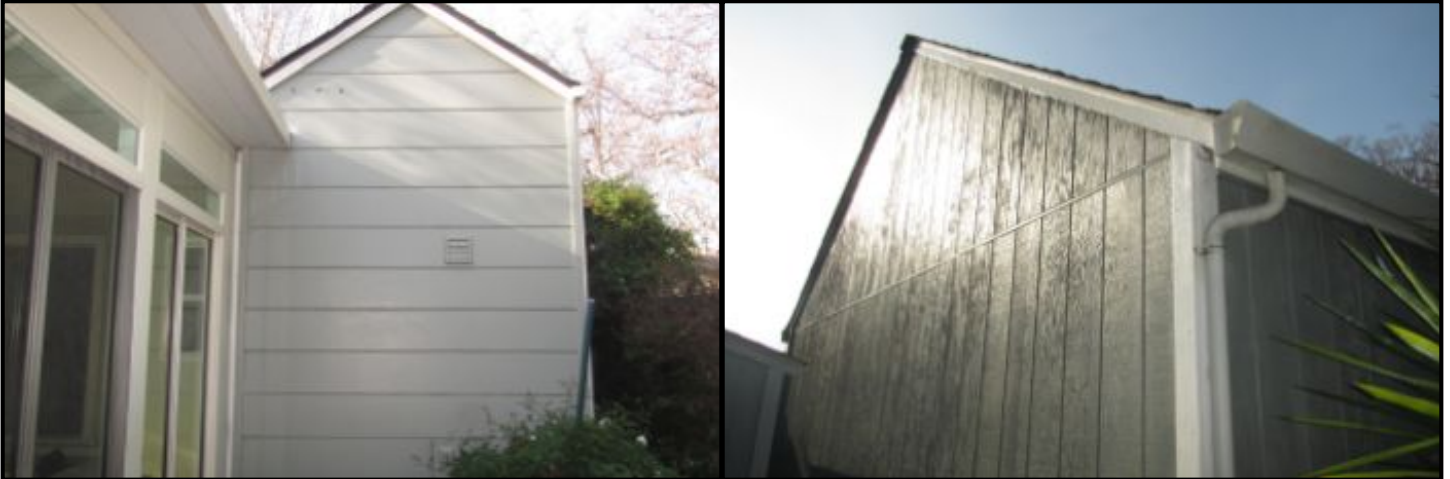
Rear of garage

- Some wood deterioration noted. Have repaired as necessary.
- Some siding deterioration noted. Have repaired as necessary.

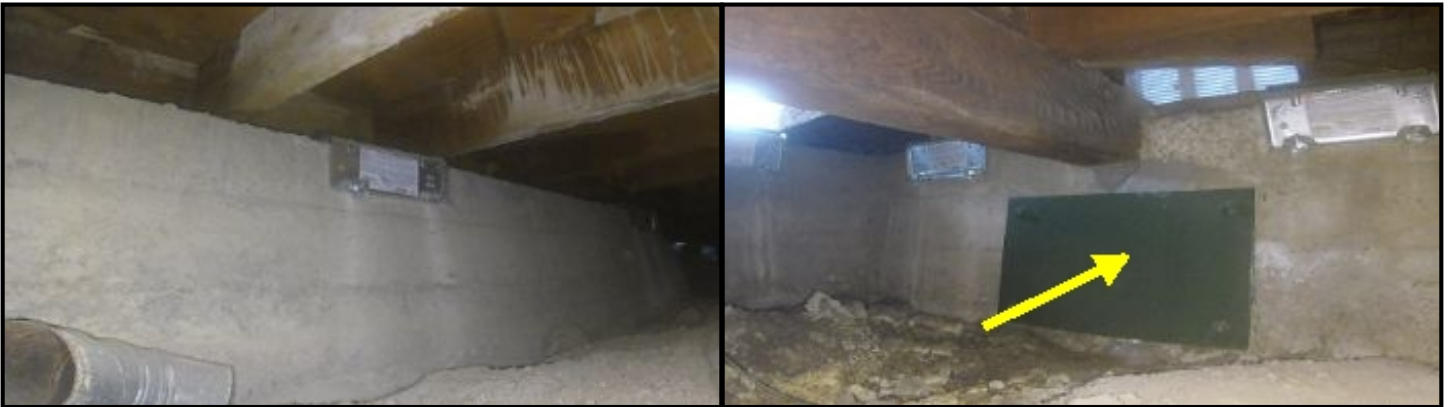
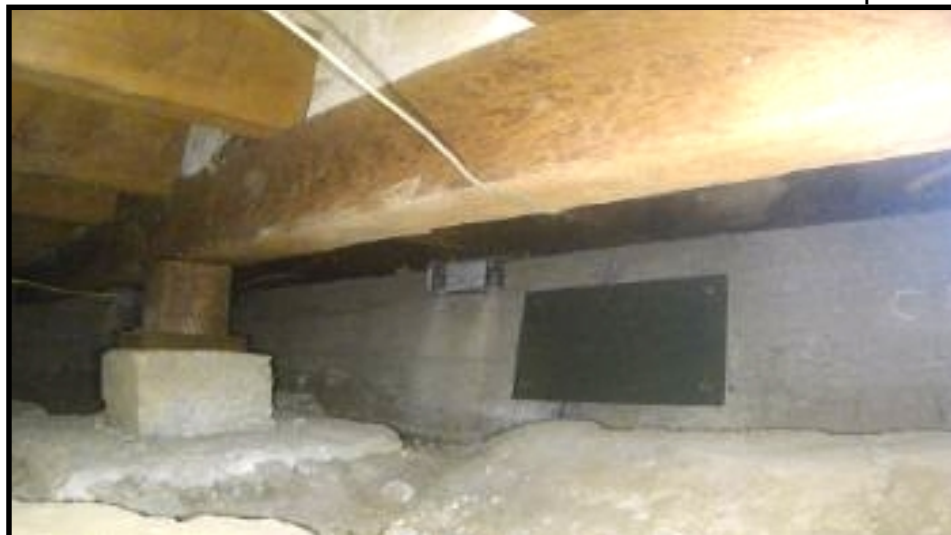
- No deficiencies were observed at the visible portions of the structural components of the home.
- Seismic anchors and repairs noted at the time of inspection

Foundation repairs noted

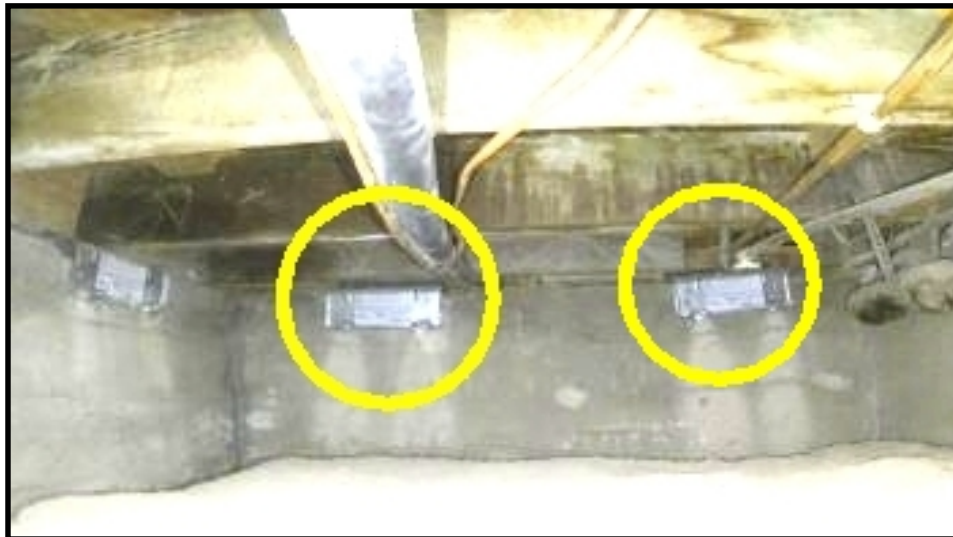
There are what appears to be retro fitted seismic anchors

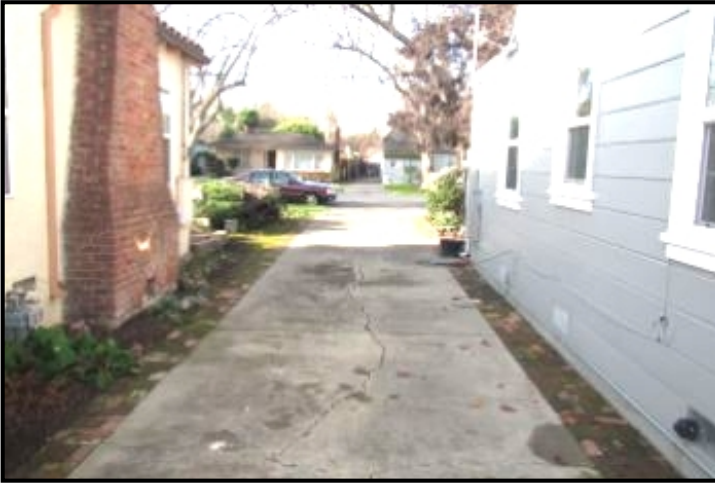
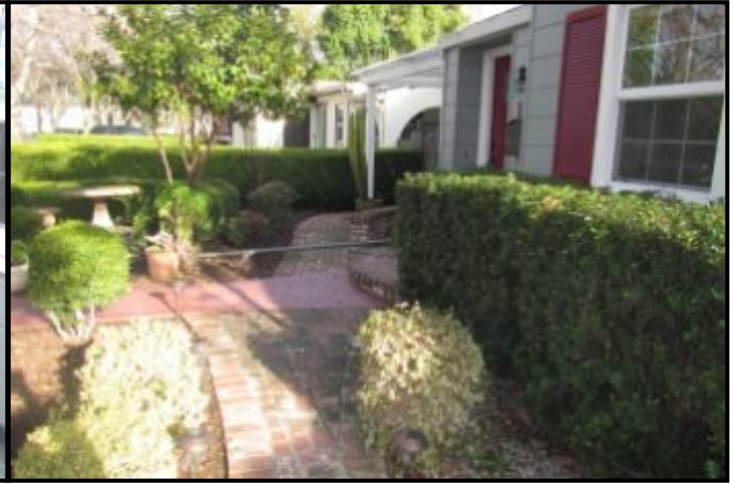
IMPROVE: Typical cracking was observed at the concrete surfaces. Further deterioration will occur as water expands and contracts from freeze and thaw cycles. Recommend sealing the cracks to prolong the life of the concrete.

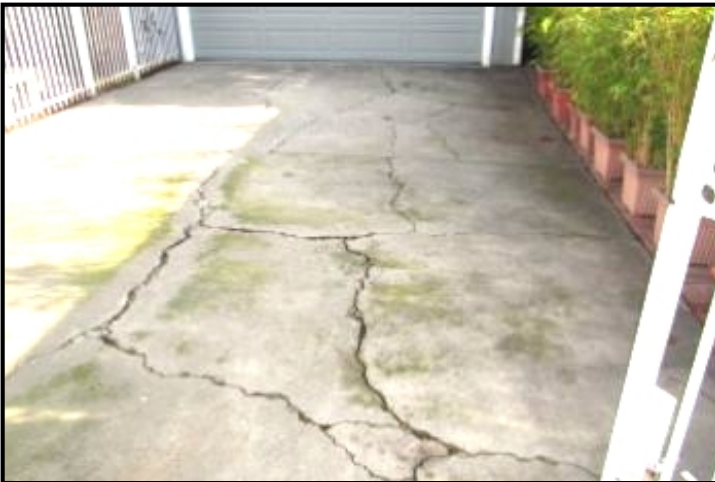
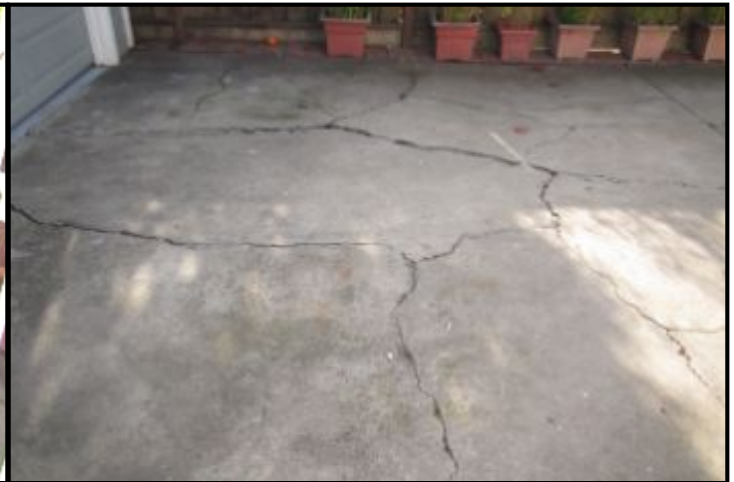
IMPROVE: Typical cracking was observed at the concrete surfaces. Further deterioration will occur as water expands and contracts from freeze and thaw cycles. Recommend sealing the cracks to prolong the life of the concrete.

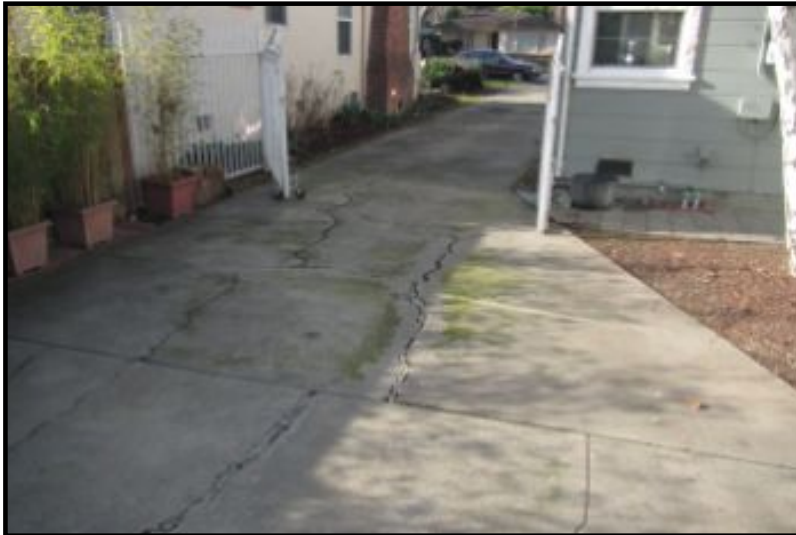
IMPROVE: Typical cracking was observed at the concrete surfaces. Further deterioration will occur as water expands and contracts from freeze and thaw cycles. Recommend sealing the cracks to prolong the life of the concrete.

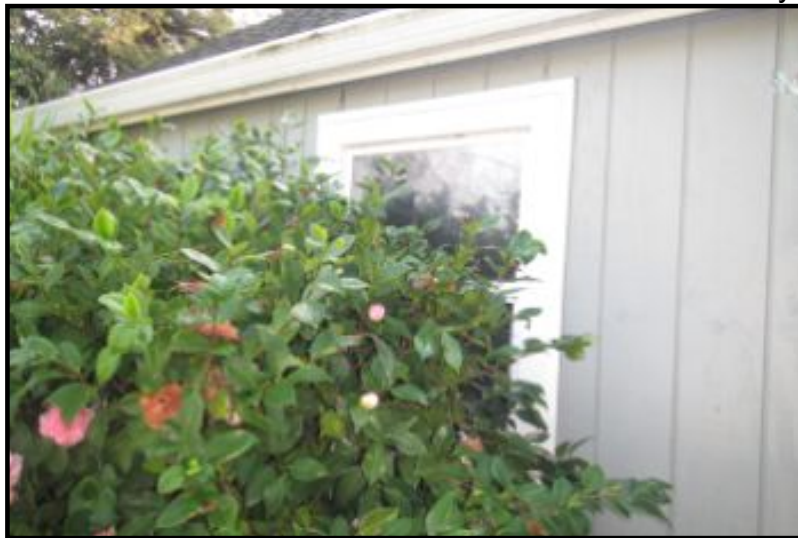
Prune or remove any plants that are in contact or proximity to home to eliminate pathways of wood destroying insects.

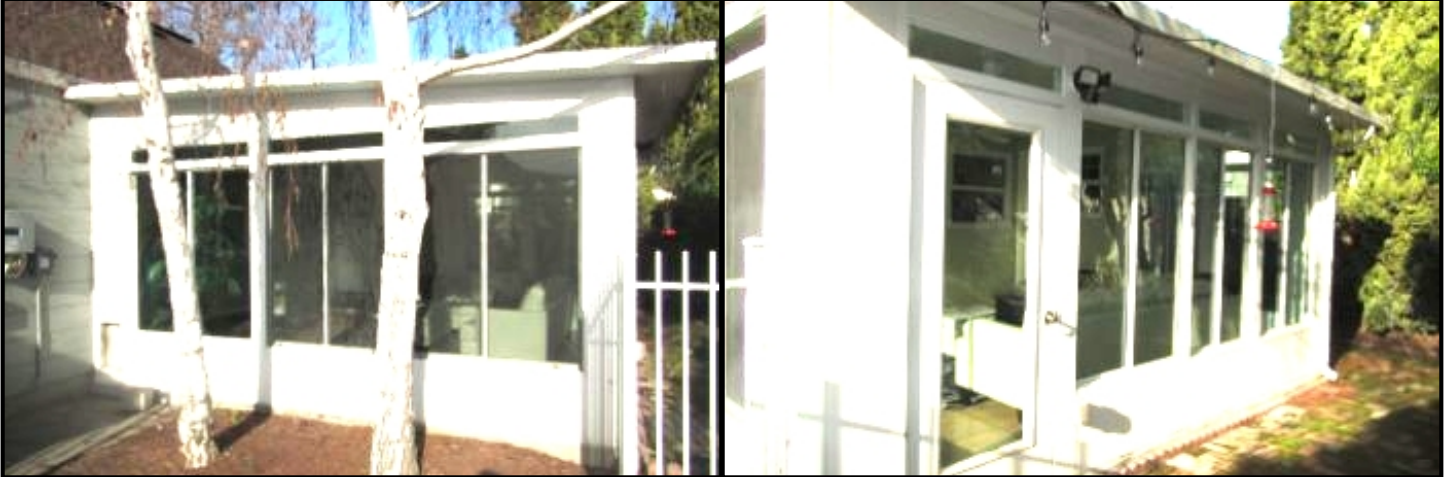
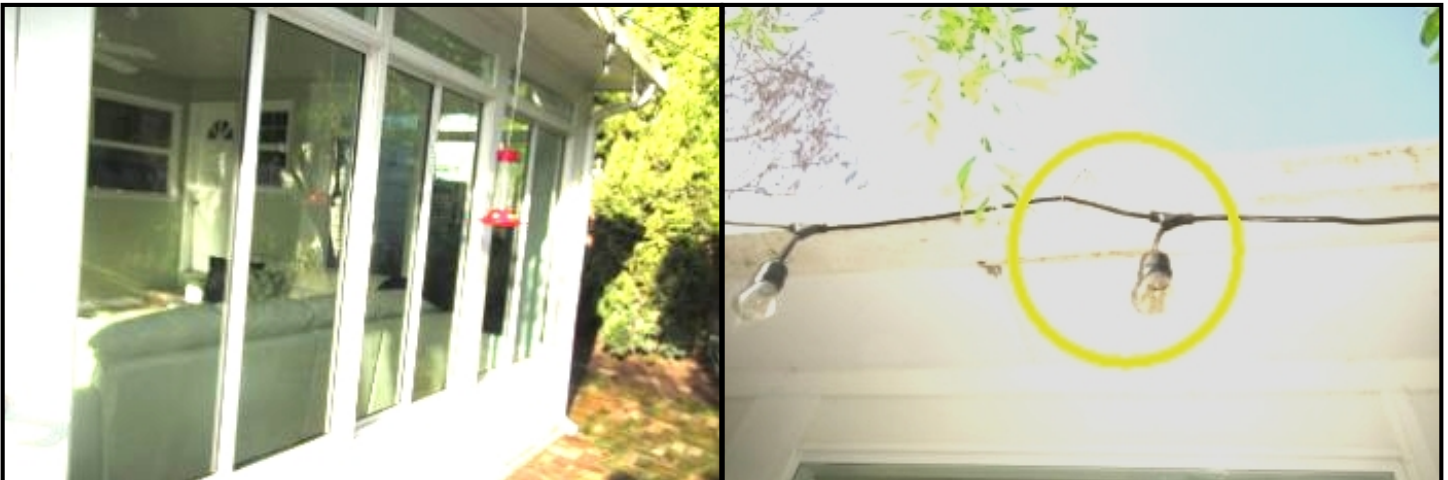
Water stains present at the overhang.
