Home Inspection Report

Inspection Address:

21080 Rainbow Pl.

Cupertino, Ca. 94014

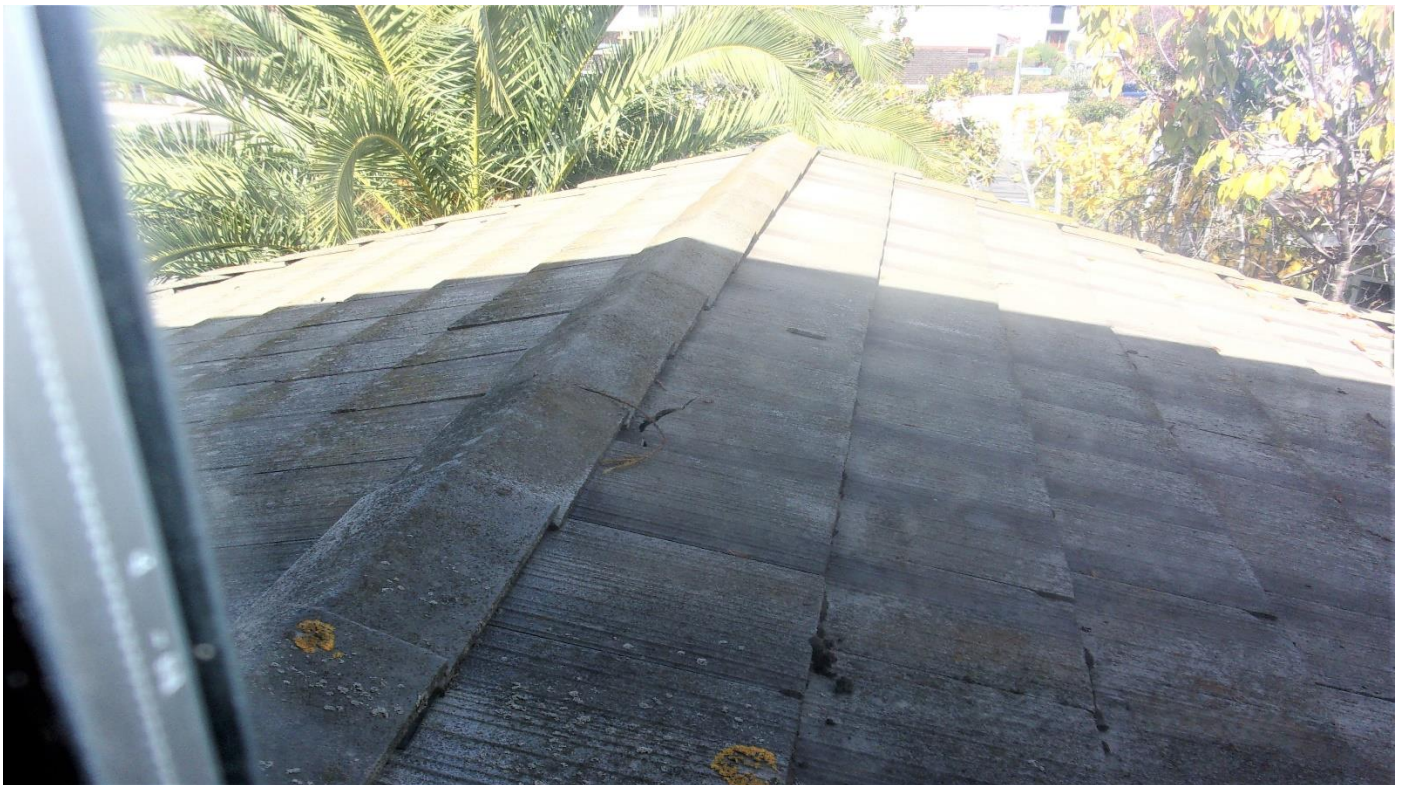
5.1 The roof appeared to be in serviceable condition at the time of inspection, however, a cracked roofing tile was observed at the lower tier located at the front of home above the living room (see photo). Loose flashing was also noted at the roof surface. It's recommended that a licensed roofing repair service inspect the roof further replace any damaged tiles and secure / seal the flashing where needed. (General Maintenance)

Cracked roofing tile visible at center of frame.

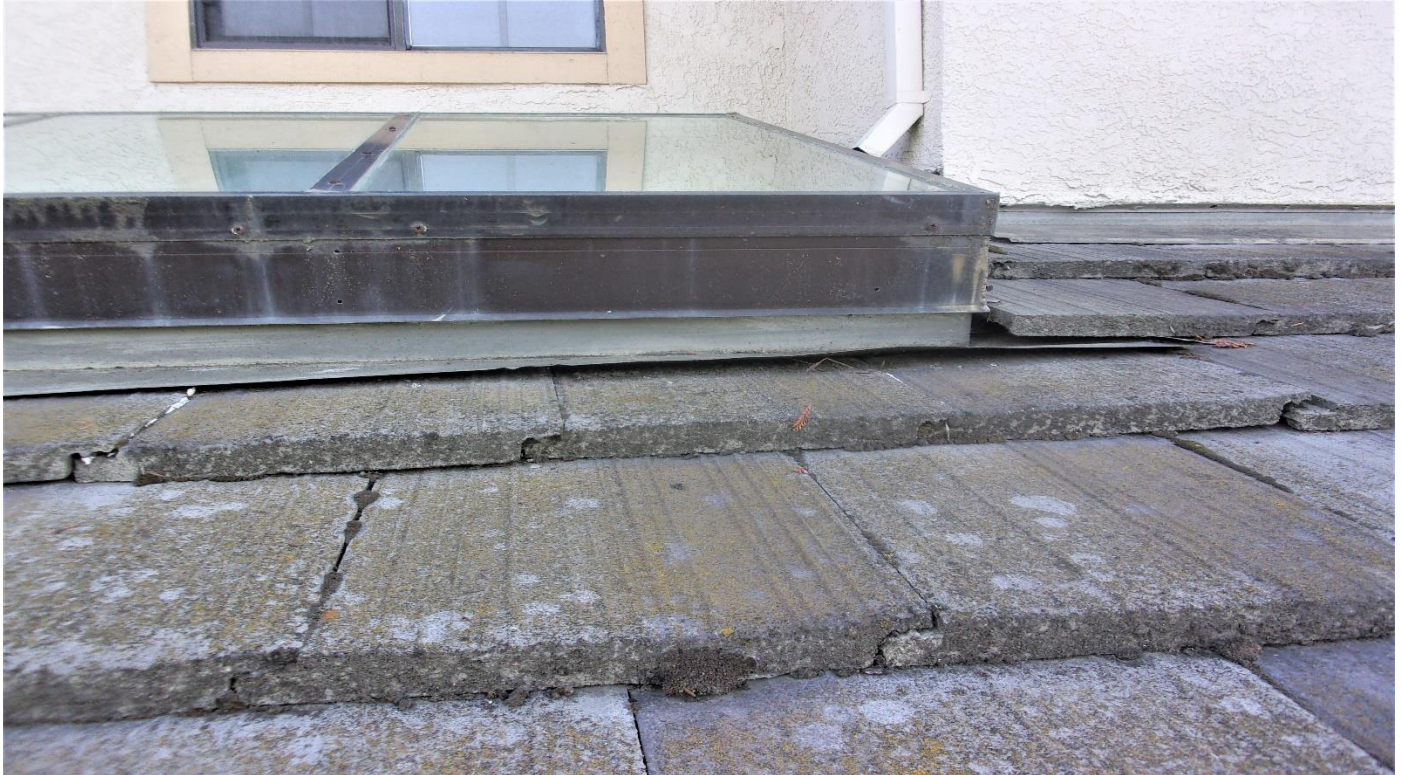
Loose flashing at roof surface.

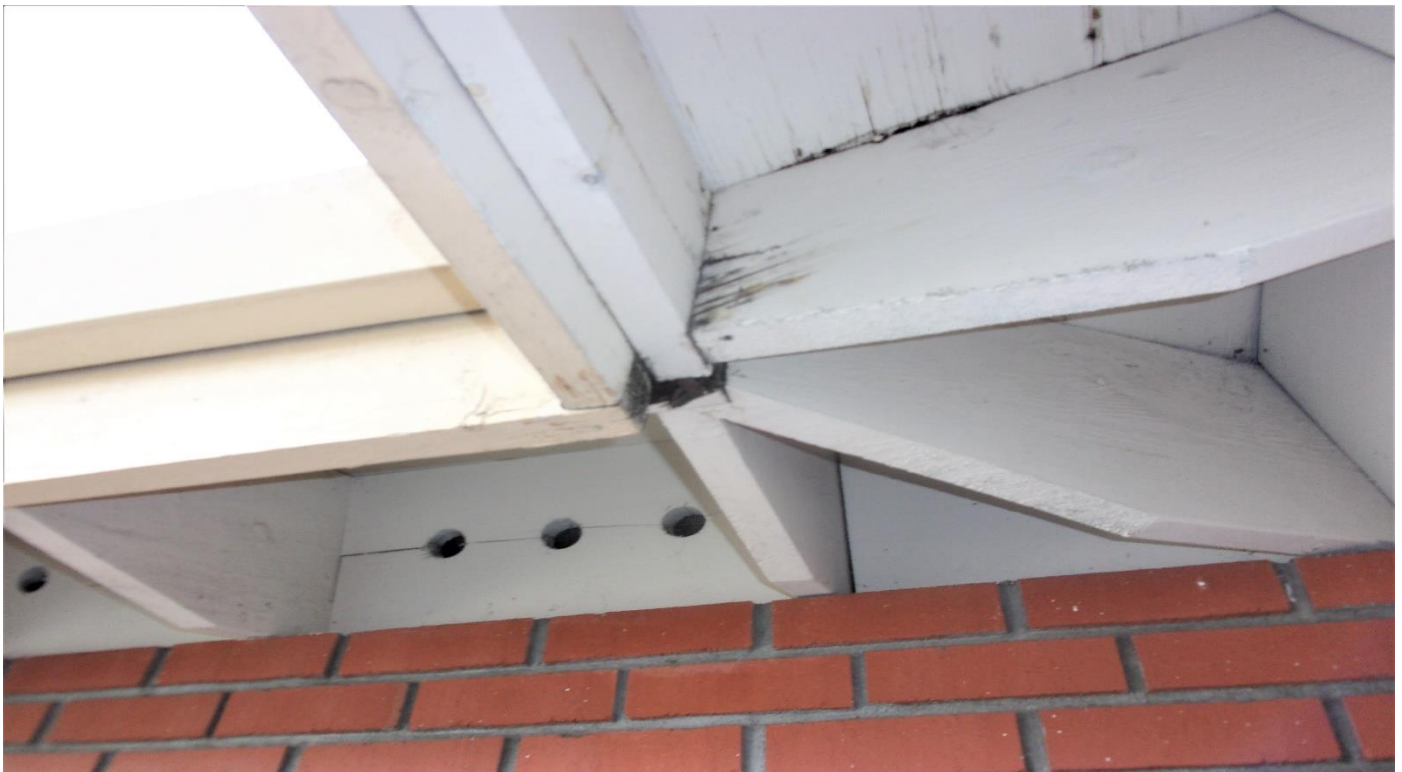
- 6.1 Moisture damaged exterior wood trim was found at the home located at the eaves above the front entranceway and at the lower window trim located at the east facing living room window (see photos). Refer to the termite report for further details and recommendations. (Section 1)

Moisture damaged wood at front lower level eaves.

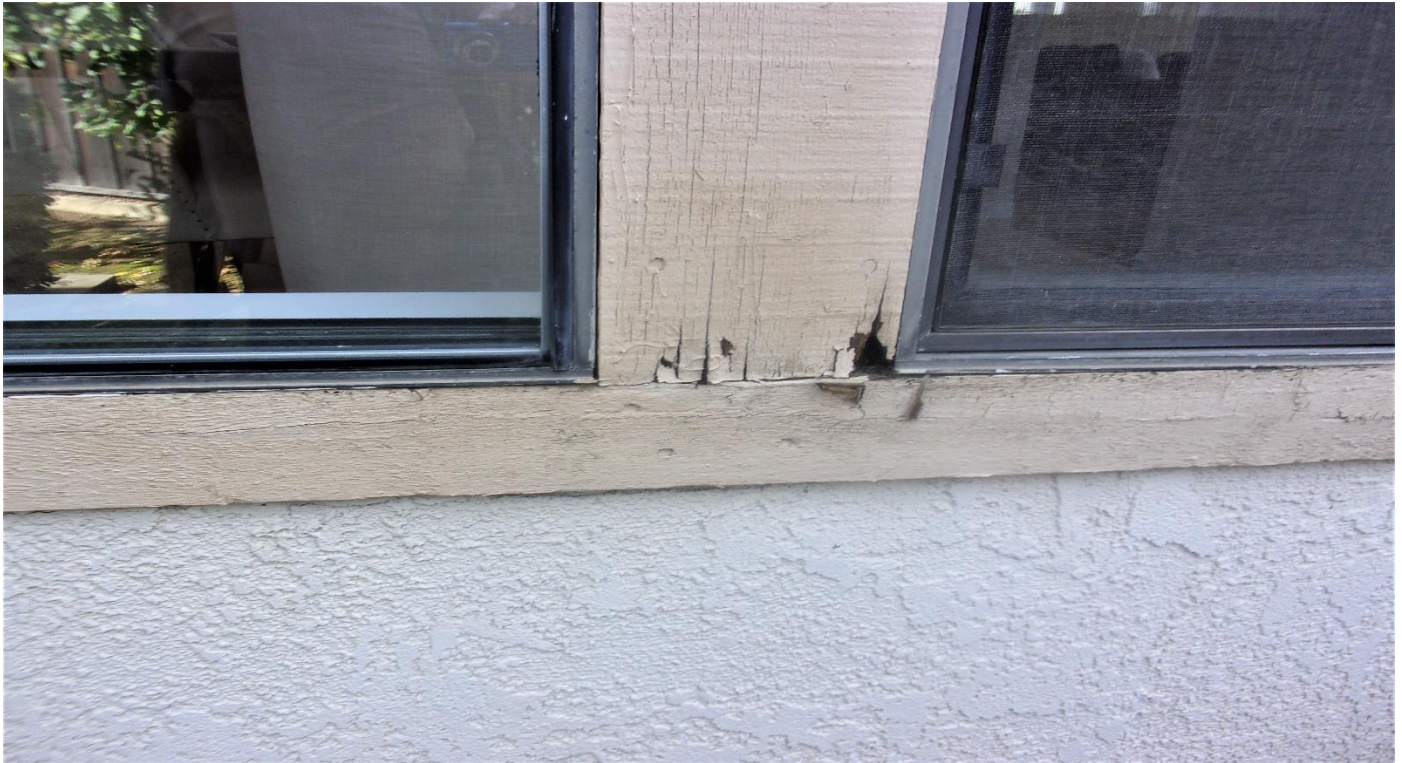
Moisture damaged wood window trim at east side of home.

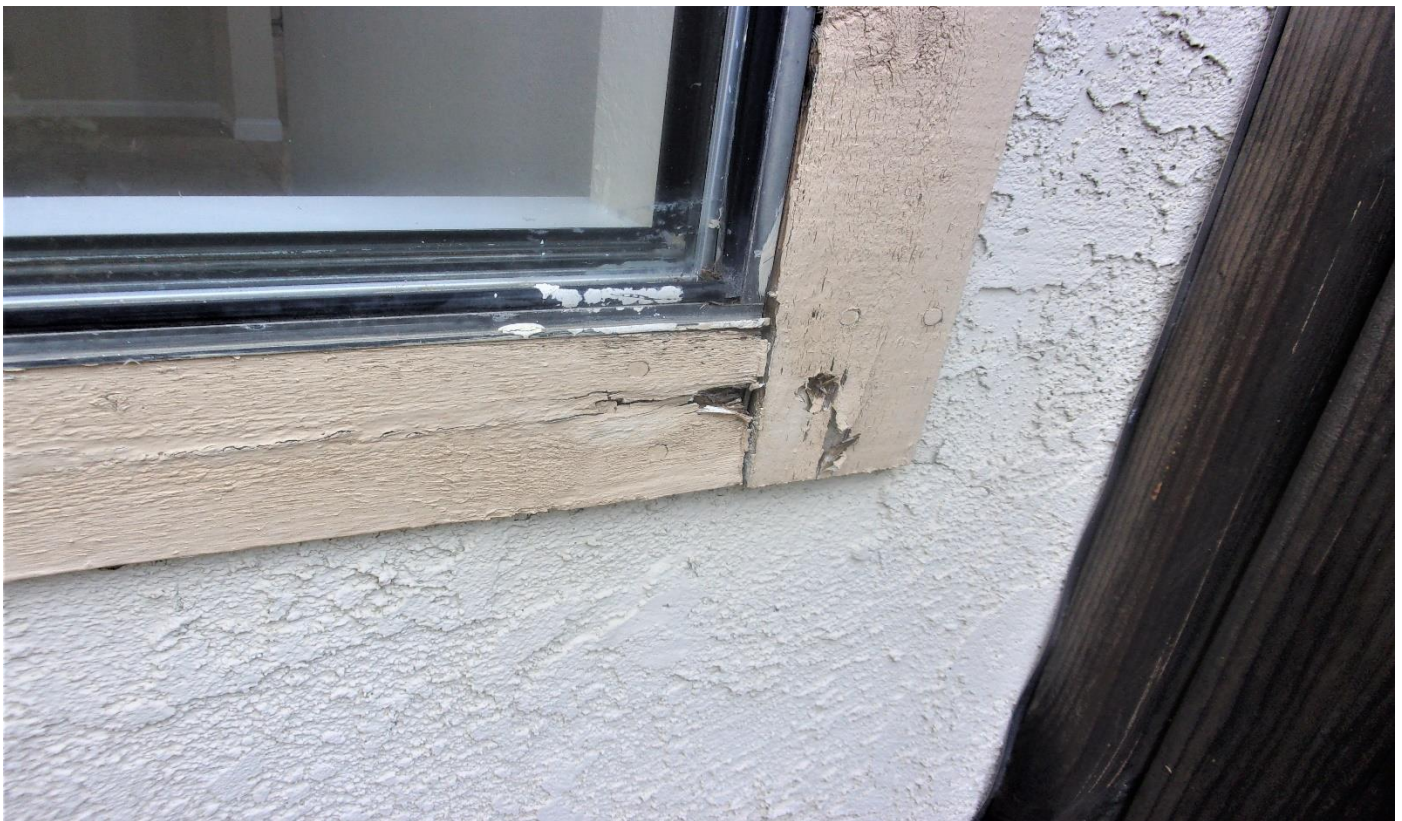
Moisture damaged wood at east side of home.
