WOOD DESTROYING PESTS AND ORGANISMS INSPECTION REPORT

| 21080 | RAINBOW PL. | CUPERTINO | 95014 | 11/05/21 | 10 |

General Description:
Two story, single family residence.

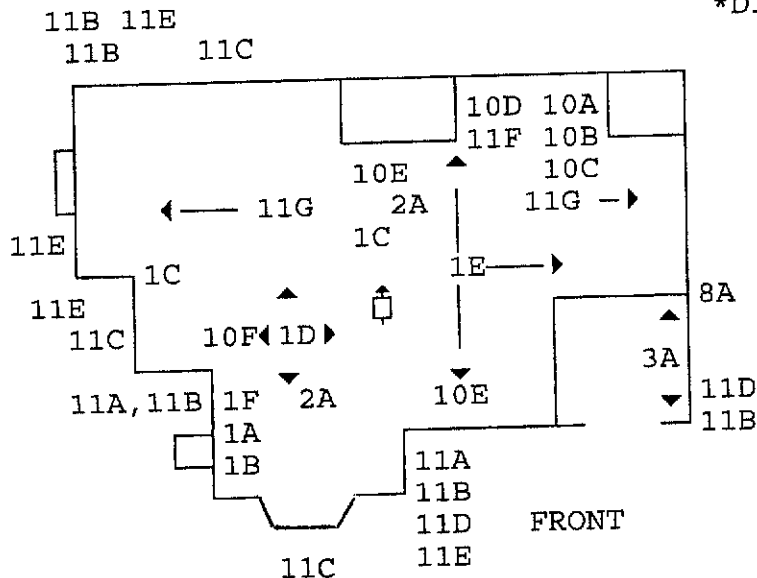
1F. FINDING: Fungus damage was found to approximately four feet of rim joist in the area indicated on the diagram.
 RECOMMENDATION: Open enough stucco from the exterior to expose all of the damaged wood members. Remove and replace the damaged rim joist as needed. Install new paper, wire and stucco where removed. The new stucco texture may vary from the existing. The owner is advised that stucco repairs are dependant on ambient outside temperatures and may take up to a week to complete. We will seal the area with one coat of primer. It will be the owner's responsibility to paint this area to match the existing area. If damage extends beyond the above outlined area or into inaccessible areas, a supplemental report will be issued with findings, recommendations and bids to complete repairs. SECTION I ITEM.

11A. FINDING: The fascia has been damaged by fungus at the area indicated on the diagram.

11C. FINDING: The window trim has been damaged by fungus at the area indicated on the diagram.

11D. FINDING: The eave boards have been damaged by fungus at the area indicated on the diagram.

RECOMMENDATION: Remove and replace the damaged wood members; paint the repaired areas with primer paint only.
SECTION I ITEM.
