*Kathy Booth
Inspection Address: 344 Greenpark Way
San Jose, CA*

Inspection Date: 7/13/2016

INSPECTOR: CRAIG MOORHEAD

Craig Moorhead
WellHouse Corporation - Building Inspections

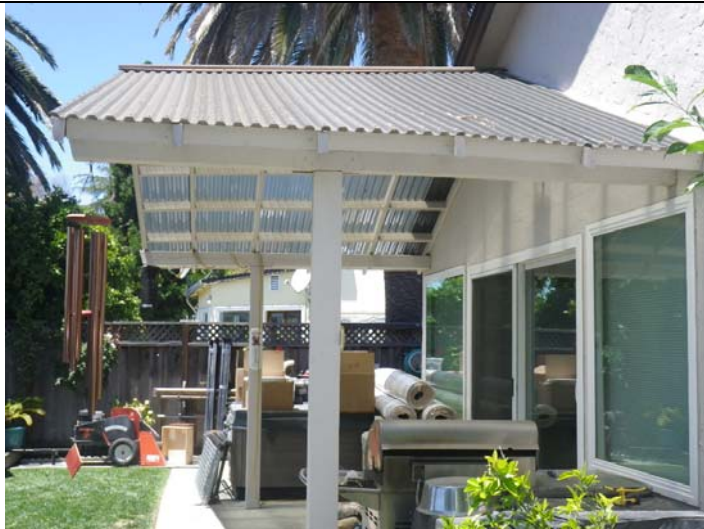
Figure 1(# 3380)

- 3.4. Astro turf was installed at the front porch and limited / prevented access for inspection .
- 3.5. Back Roof Cover: A significant amount of sagging was noted at the roof cover rear most framing and was related to there having no rafter ties installed. Further attention by a qualified contractor is recommended and will likely include temporarily pulling the structure back together and installing rafter tie(s) as needed. (See figure # 1)

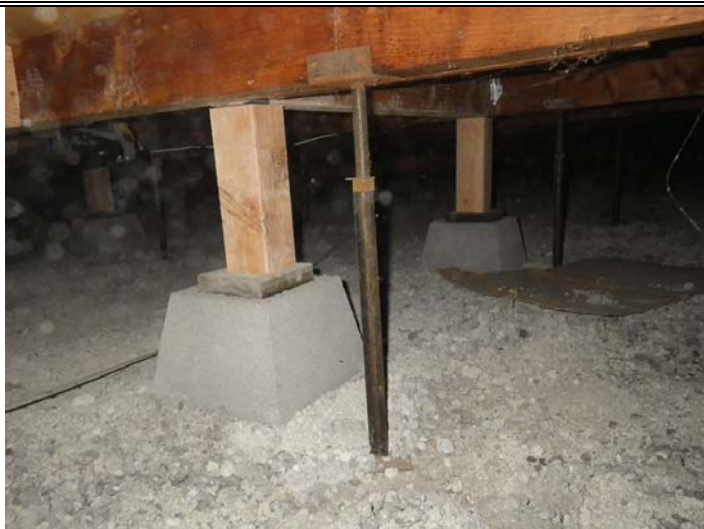
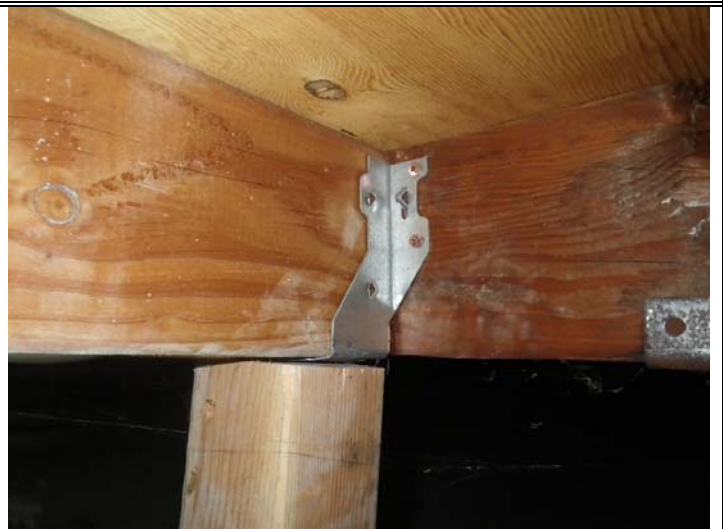
- 4.1. Concrete piers which appeared to have been added were installed without being set into concrete puddle pads and noted in four locations in the kitchen island crawl space area. This may allow seasonal movement / settling of the piers in the future. Additionally, missing nailing was visible at the beam hangers installed at the floor framing at this location. Further attention/modification is recommended by a qualified contractor. (See figures # 3, 4)

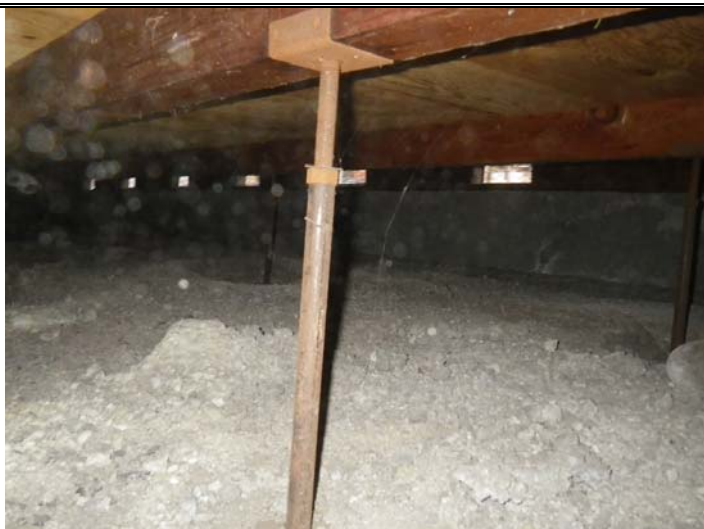
Figure 5(# 3403)

- 4.4. Crawl Space: Moisture stains were noted at the rim joist framing visible at the back perimeter locations. The source of the moisture appeared to possibly be a periodic condition related to moisture coming through the vent screens. Further attention is recommended. Interested parties should refer to the pest control report for possible related comments. (See figure # 5)

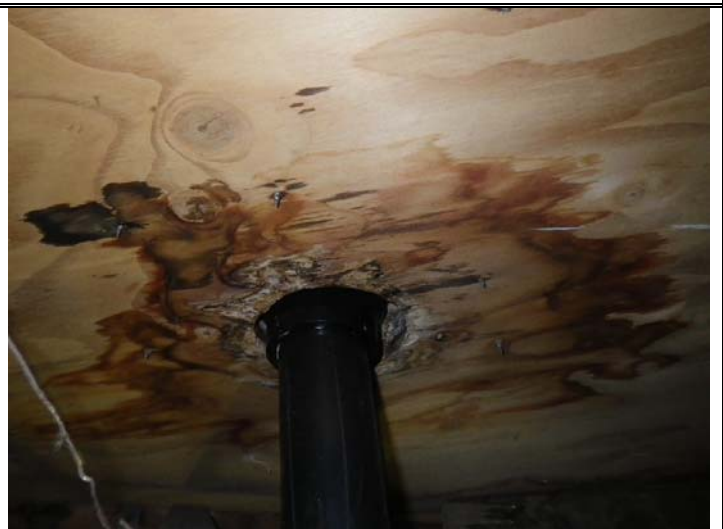
Figure 6(# 3397)

- 4.5. Crawl Space: Notable moisture stains and mineral deposits were visible at the surface of the subfloor adjacent to the master bath shower drain. The shower was tested at the time of inspection by turning on the water in a manner consistent with daily use. However, the shower was not tested by filling it with water since this type of test is generally performed during the pest control inspection. It is recommended to refer to the pest control report for possible related comments. (See figure # 6)

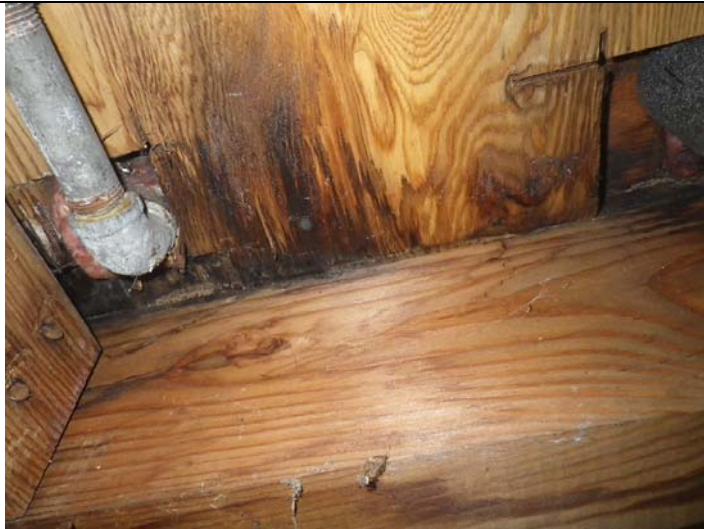
Figure 7(# 3416)

- 4.3. Crawl Space: Moisture damage was noted at the sub-floor / framing visible from the sub-area(s) including the master bath shower and may be related to damage left during previous repairs. Removal of the damaged wood and repair is recommended by a licensed contractor. Interested parties should refer to the pest control report for possible comments. (See figure # 7)

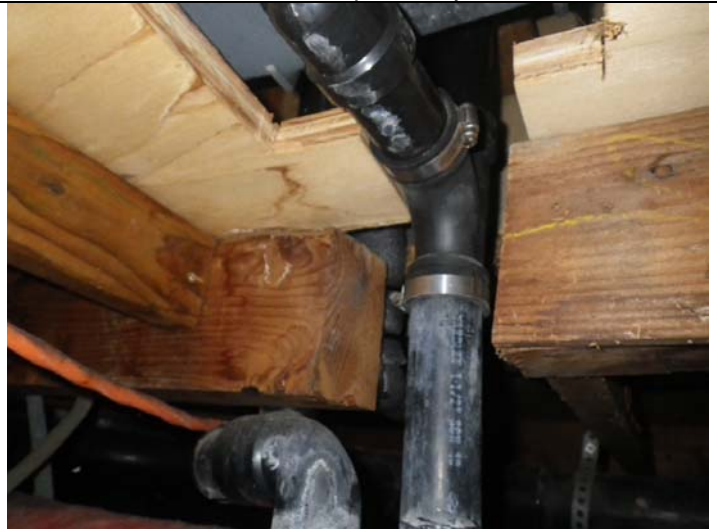
Figure 8(# 3395)

- 4.2. Crawl Space: A cut floor girder that was not properly supported and sagging was visible adjacent to the hall bath tub drain. This is in need of repair by a qualified contractor. (See figure # 8)

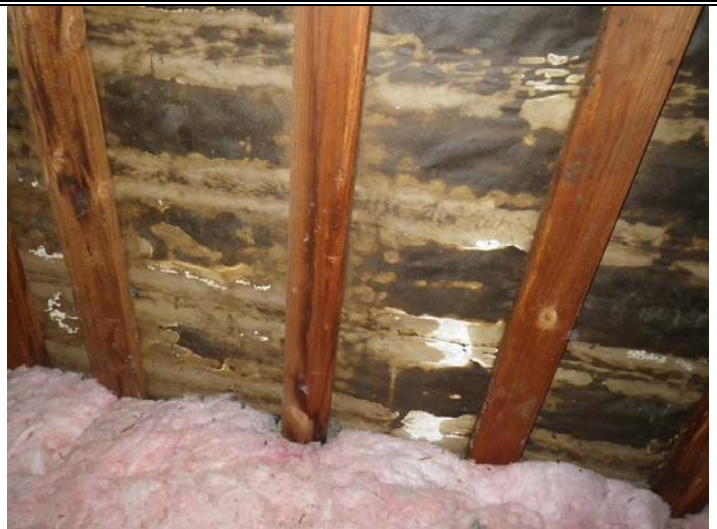
Figure 10(# 3390)

- 7.1. Stains and holes were noted at the exterior wall moisture barrier and visible from the back location of the attic interior. While no evidence of current related conditions were visible with the adjacent framing when examined, the penetrations in the barrier may allow moisture to contact the adjacent wood framing which could in-turn deteriorate or damage the framing. Monitor for possible changes. Further attention and preventative repair by a qualified contractor is recommended. (See figure # 10)

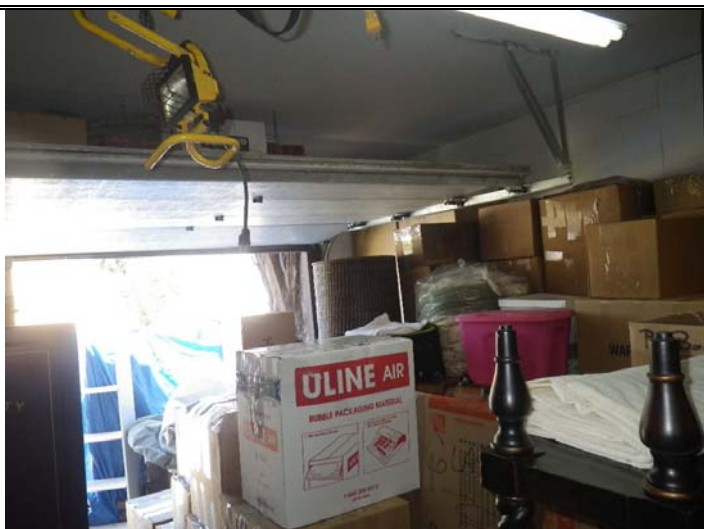
Figure 11(# 3381)

Severely limited access for inspection of the general areas of the attached garage interior was noted because of personal storage; no opinion was rendered for the areas which were not visible when inspected. (See figure # 11)

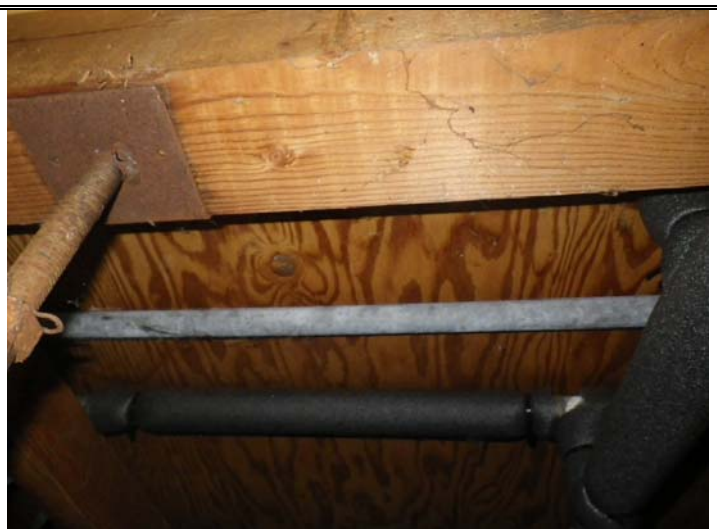
Figure 12(# 3398)

Insulation was noted at varied water piping when inspected. While this is an upgrade, it limits visual access for inspection. (See figure # 12)

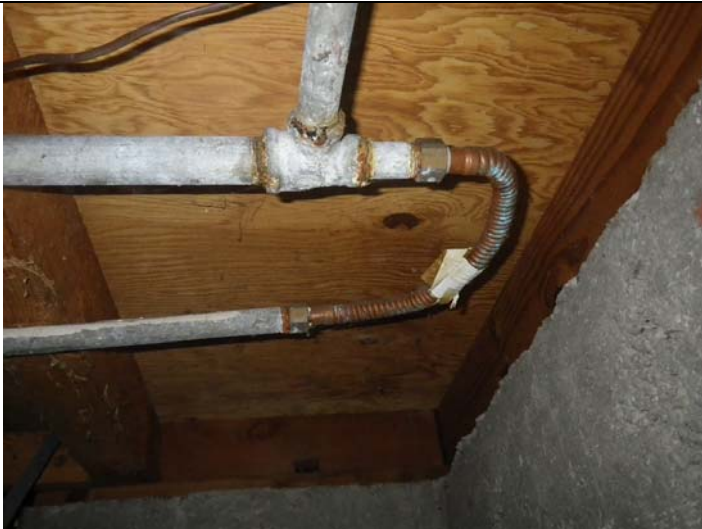
Figure 13(# 3401)

- 12.5. Crawl Space: Improper plumbing supply piping was visible at of the front area and included appliance connector pipes. Building standards generally require plumbing supply piping to be of the material that is specifically approved (copper and galvanized steel generally) when located within the perimeter of the foundation. Removal and replacement of the appliance connector is recommended. (See figure # 13)

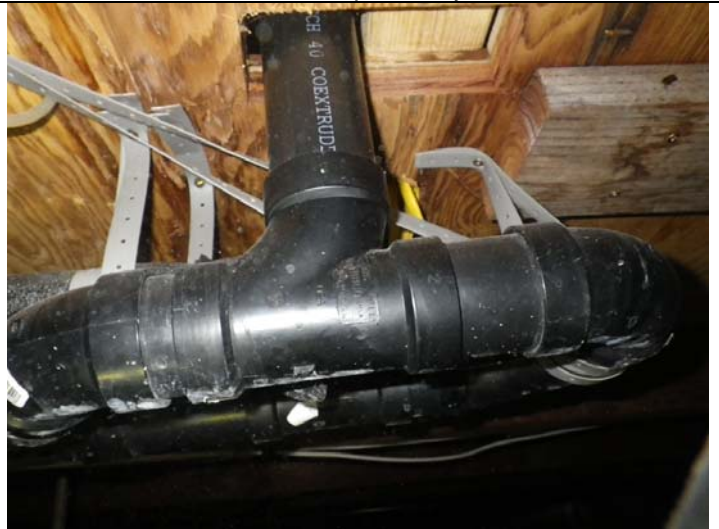
Figure 14(# 3409)

12.7. Crawl Space: Was installed in an improper orientation at the kitchen area drain(s) when examined. Clogging of the drain may occur easier than with a correct/standard drain installation. Further attention by a qualified plumbing contractor is recommended. (See figure # 14)

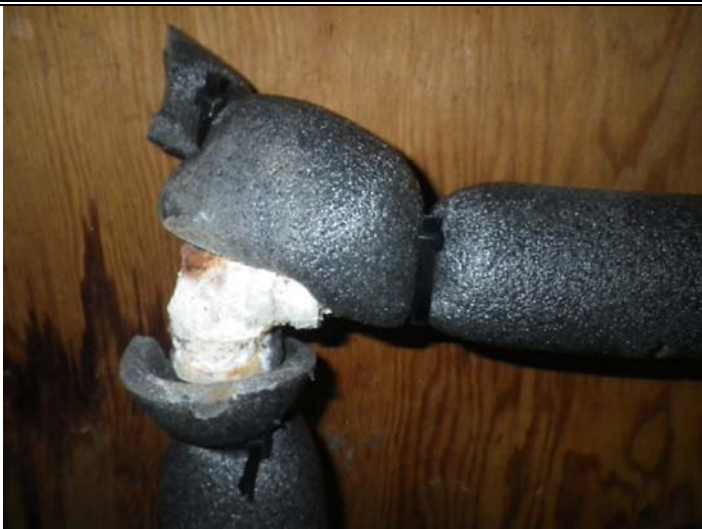
Figure 15(# 3414)

- 12.4. Crawl Space: Corrosion and no evidence of current leakage visible at the plumbing piping, visible at the varied location(s). This may be related to or an indication of the system aging and may require future attention and/or replacement. Interested parties should refer to a licensed plumber for repair and/or further information regarding the serviceable life of the water supply. (See figure # 15)

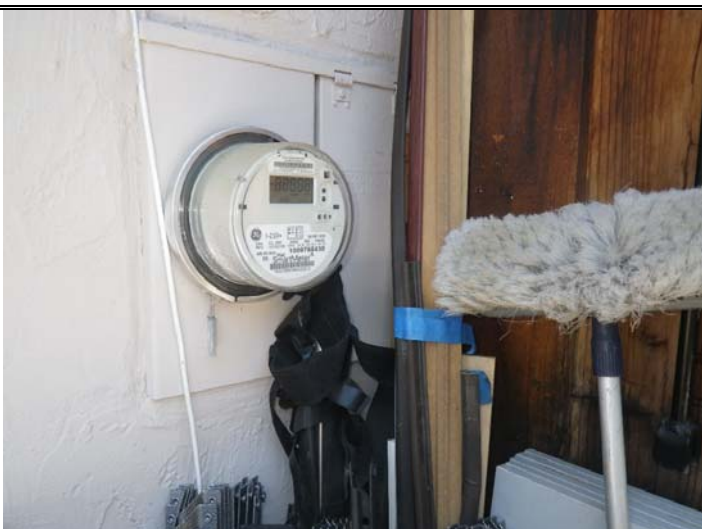
Figure 17(# 3379)

13.4. Main Electrical Panel: The main electrical was not accessible for inspection because of obstructions and no opinion was rendered regarding it's condition. Access to the panel should be maintained and the panel remain unlocked. Inspection of this panel is recommended once access is provided. An additional fee will be charged for a return trip to the property - please contact our office to coordinate a time. (See figure # 17)

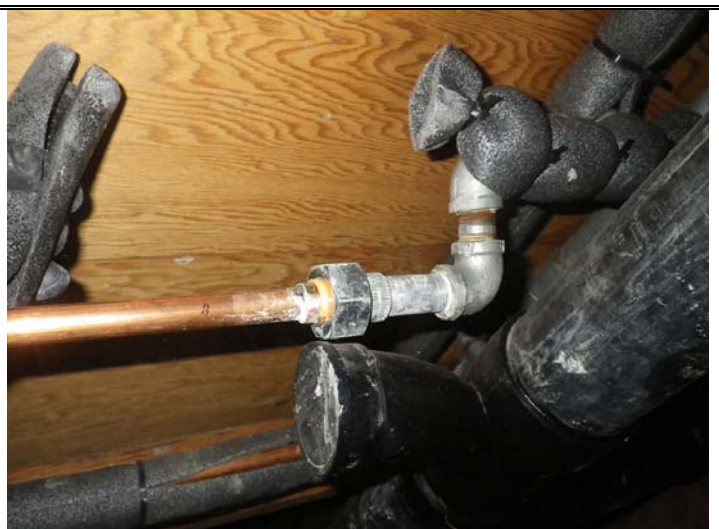
Figure 18(# 3418)

13.7. Crawl Space: Dielectric unions were installed at the plumbing supply piping system to connect the dissimilar copper and galvanized steel piping. While this is a proper plumbing connection for these two metals, this installation may have caused the electrical bonding and/or grounding to become discontinuous. Verifying proper grounding / bonding and/or modifying the installation is recommended to maintain/provide a safe installation. One means of providing continuous bonding/grounding is to install ground clamps and a conductor to jumper across the dielectric union. Another would be to replace the dielectric union with a 6 inch minimum length brass nipple, however, all municipalities building officials do not accept this installation. (See figure # 18)
