AAA Home Inspections

Property Inspection Report

1120 N. 3rd Street , San Jose, CA
Inspection prepared for: Richard Wells & Ann Wells
Real Estate Agent: George Sudol - Bay Realty Services

Date of Inspection: 1/31/2020 Time: 9:00
Age of Home: 81 Size: 1379 s.f.
Weather: Sunny

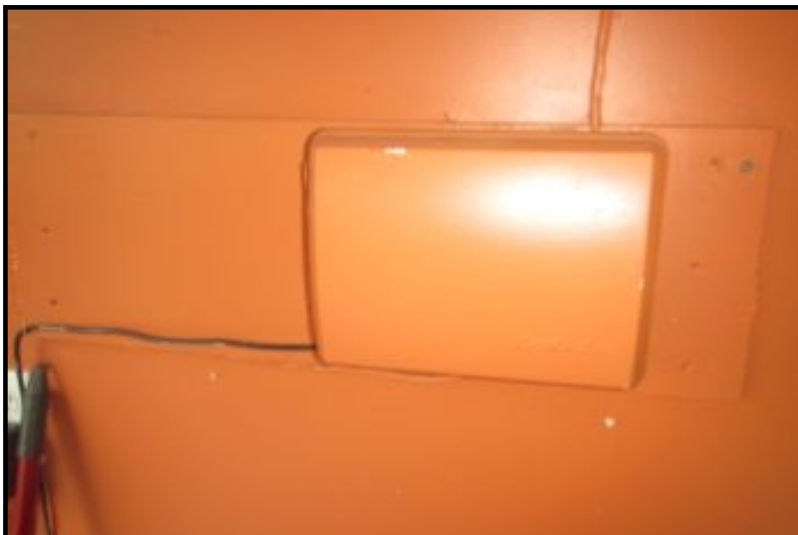
- The sprinkler system operates with a control panel located in the garage.

Sprinkler timer noted
