*Kathy Booth
Inspection Address: 344 Greenpark Way
San Jose, CA*

Inspection Date: 7/13/2016

INSPECTOR: CRAIG MOORHEAD

Craig Moorhead
WellHouse Corporation - Building Inspections

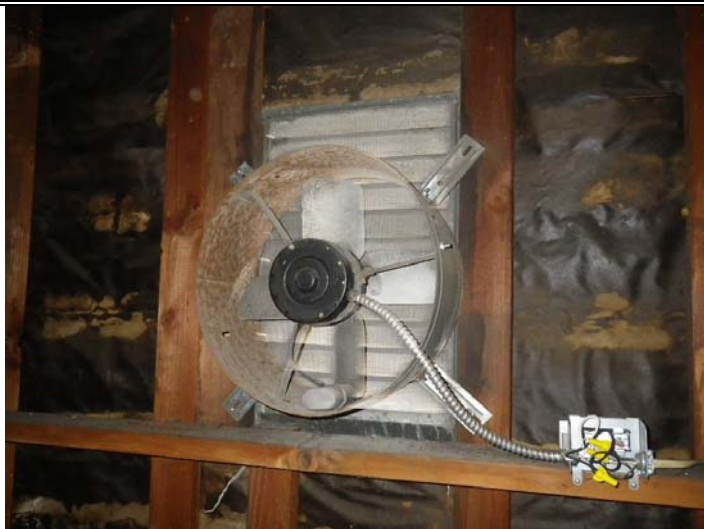
Figure 9(# 3388)

Ventilation provisions for the attic(s) included perimeter eave and gable and roof mounted vents. Maintaining good attic ventilation is beneficial to reduce the attic temperatures in the summer season and to prevent water condensation in the winter season. Perimeter vents were generally installed to provide sub-area ventilation; The vent coverings should be maintained with openings no larger than 1/4 inch to prevent possible access by insects and rodents. An exhaust fan was installed to ventilate the attic, however, the unit was not connected electrically further attention is needed. Interested parties should refer to the current owner for possible related and/or historic information. (See figure # 9)

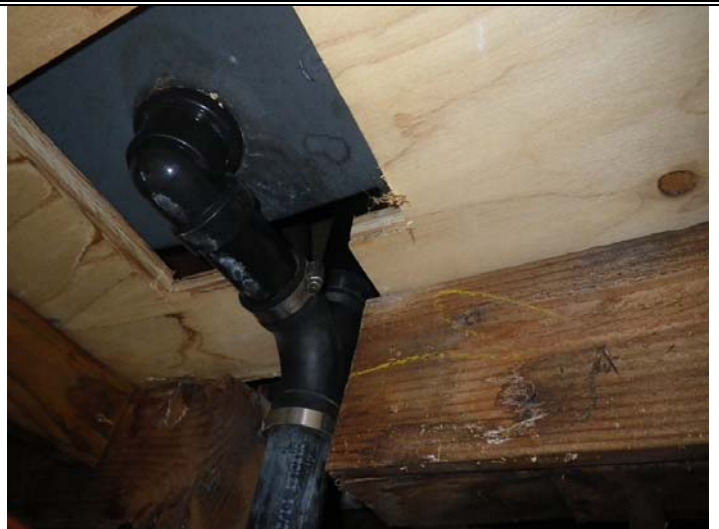
Figure 16(# 3394)

12.6. Crawl Space: The drain /waste piping appeared to have an unrated coupling / connection and visible at the hall bath tub location. While it appeared to be functional when examined, it may not have as long of a serviceable life as a rated / standard installation. Additionally, the couplings generally need (required by the manufacturer) a nearby pipe support on each side of it. For further inspection, interested parties should refer to a licensed plumbing contractor. (See figure # 16)

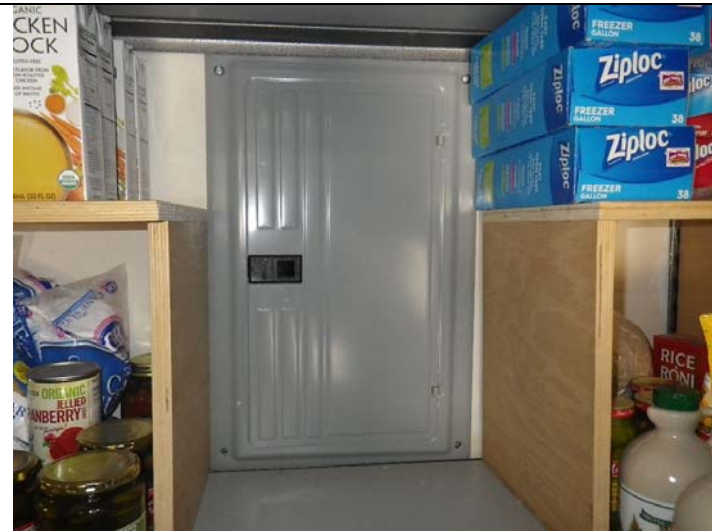
Figure 19(# 3382)

13.9. Garage Sub-panel: The electrical panel was not accessible for inspection because of shelves and personal storage items and no opinion was rendered regarding it's condition. Access to the panel should be maintained and the panel remain unlocked. Inspection of this panel is recommended once access is provided. An additional fee will be charged for a return trip to the property. (See figure # 19)

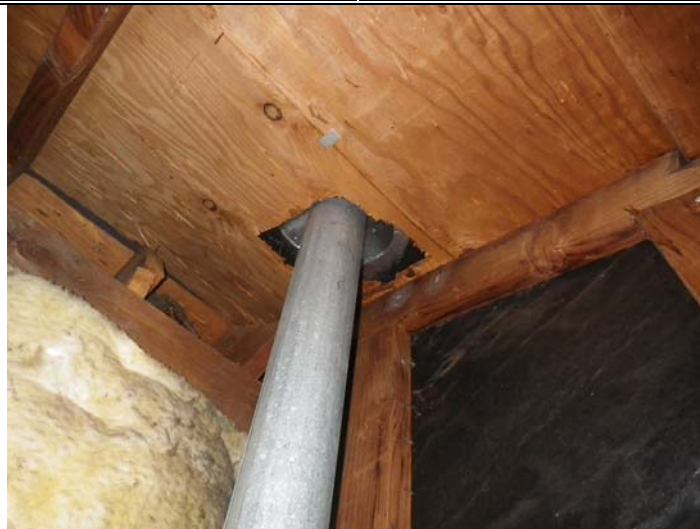
Figure 21(# 3383)

14.2. The double wall, type B water heater flue vent was installed with insufficient clearances to combustibles including the roof sheathing. This condition is in need of modification / repair to provide safe operation and should include minimum clearances of one (1) inch for type B, six (6) inches for single wall rated vents and eighteen (18) inches for non-rated vents. It is recommended to have a qualified contractor repair/modify as needed. (See figure # 21)
