AAA Home Inspections

Property Inspection Report

1120 N. 3rd Street , San Jose, CA
Inspection prepared for: Richard Wells & Ann Wells
Real Estate Agent: George Sudol - Bay Realty Services

Date of Inspection: 1/31/2020 Time: 9:00
Age of Home: 81 Size: 1379 s.f.
Weather: Sunny

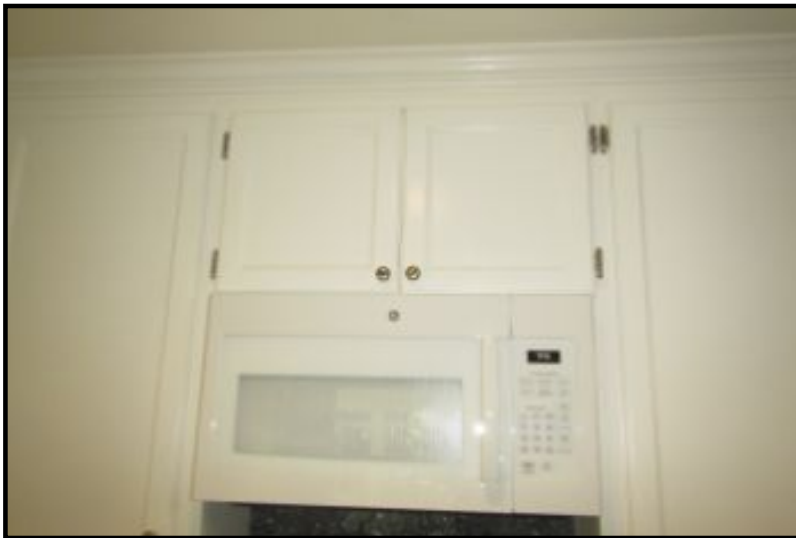
Microwave vent combination noted

- Built-in microwave ovens are tested using normal operating controls. Unit was tested and appeared to be serviceable at time of inspection. Leak and/or efficiency testing is beyond the scope of this inspection. If concerned, client should seek further review by qualified technician prior to closing.

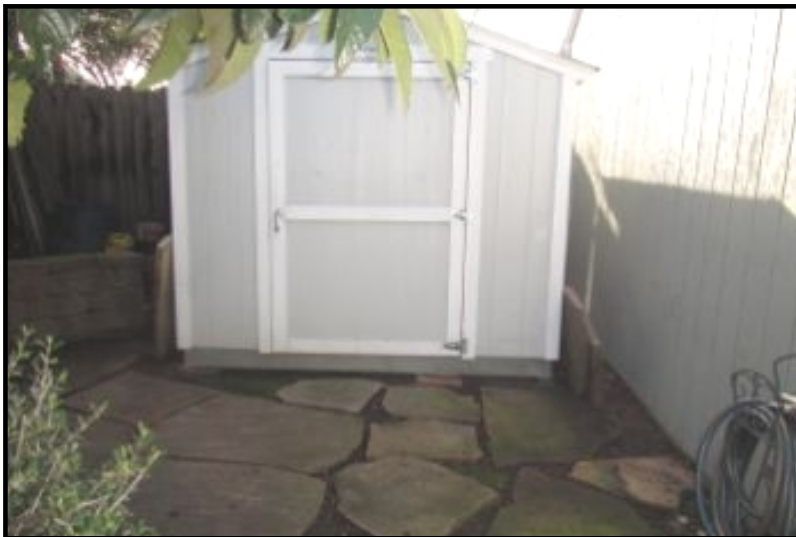
- No major system safety or function concerns noted at time of inspection.
- Out buildings and sheds are excluded from this report.

Out buildings and sheds are excluded from this report.

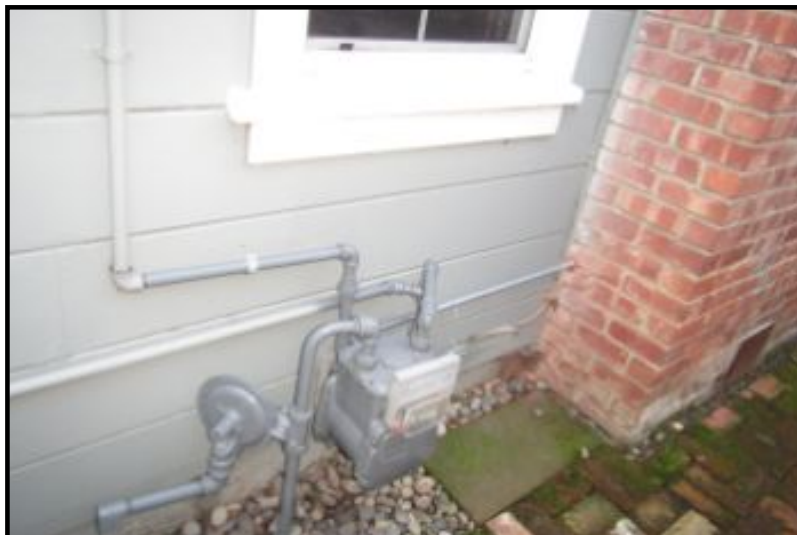
- Meters located at exterior. All gas appliances have cut-off valves in line at each unit. No gas odors detected.

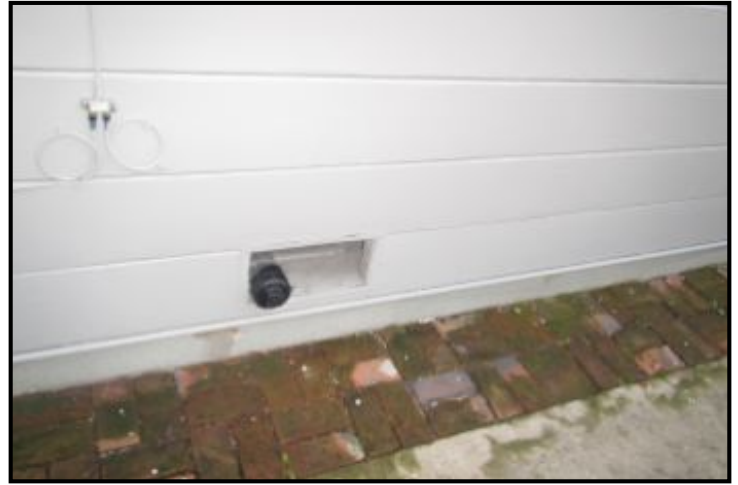
Main water shutoff noted

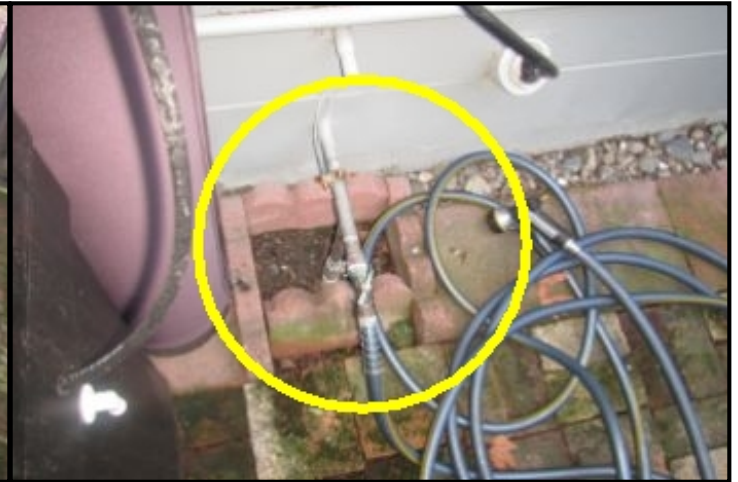
Water softener

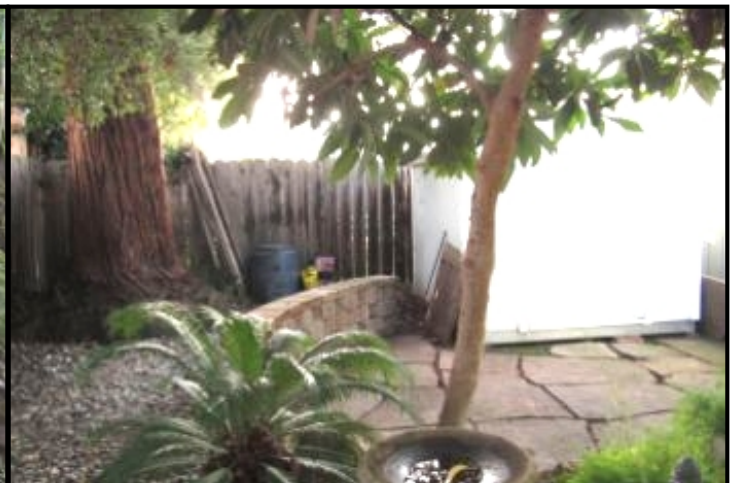
- No major system safety or function concerns noted at time of inspection.
- There was a pond present at the time of inspection. Because of senate bill 442, this would should have a mesh enclosure that is 4 feet tall with a self closing self latching gate. There should be self closing gates coming into the back yard.
- There was no ASTM rated cover
- There was no ASTM rated cover
- There were no pool alarms at the adjacent door or windows

Pond noted at the back yard

There was a pond present at the time of inspection
